**DETERIORATING BURIED INFRASTRUCTURE
MANAGEMENT CHALLENGES AND STRATEGIES**

Prepared by
American Water Works Service Co., Inc.
Engineering Department

May, 2002

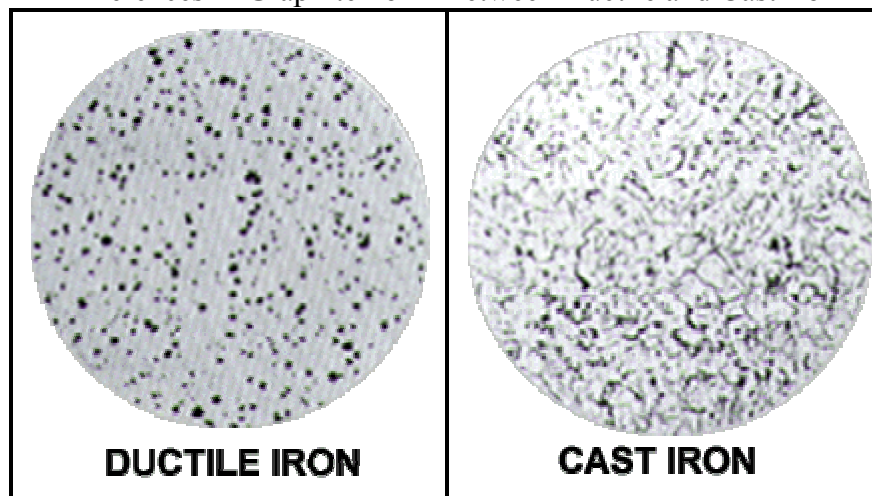
Beginning in the mid-1950's, improvements in iron pipe manufacturing and technology began to emerge. The first improvement was the advent of the rubber gasketed joint that alleviated shortcomings associated with leadite and rigid joints. The next major improvement was the introduction of ductile iron pipe in the late 1960's. Ductile iron differs from cast iron in that its graphite form is spheroidal, or nodular, instead of the flake form found in cast iron. This change in graphite form is accomplished by adding an inoculant, usually magnesium, to molten iron of appropriate composition during manufacture. Not only is ductile iron pipe stronger than cast iron pipe, it is also more resistant to corrosion. Cast iron pipes, whether pit cast or spun cast, are susceptible to "graphitic" corrosion where which an electrochemical reaction occurs between the cathodic graphite component (flakes) and the anodic iron matrix causing metal loss. Due to its spheroidal graphite form, ductile iron is not subject to graphitic corrosion and also has approximately twice the strength of cast iron as determined by its mechanical properties. Its impact strength and elongation are also many times greater than cast iron. Exhibit No. 1 below shows the molecular differences in ductile iron and cast iron.

Differences in Graphite Form Between Ductile and Cast Iron

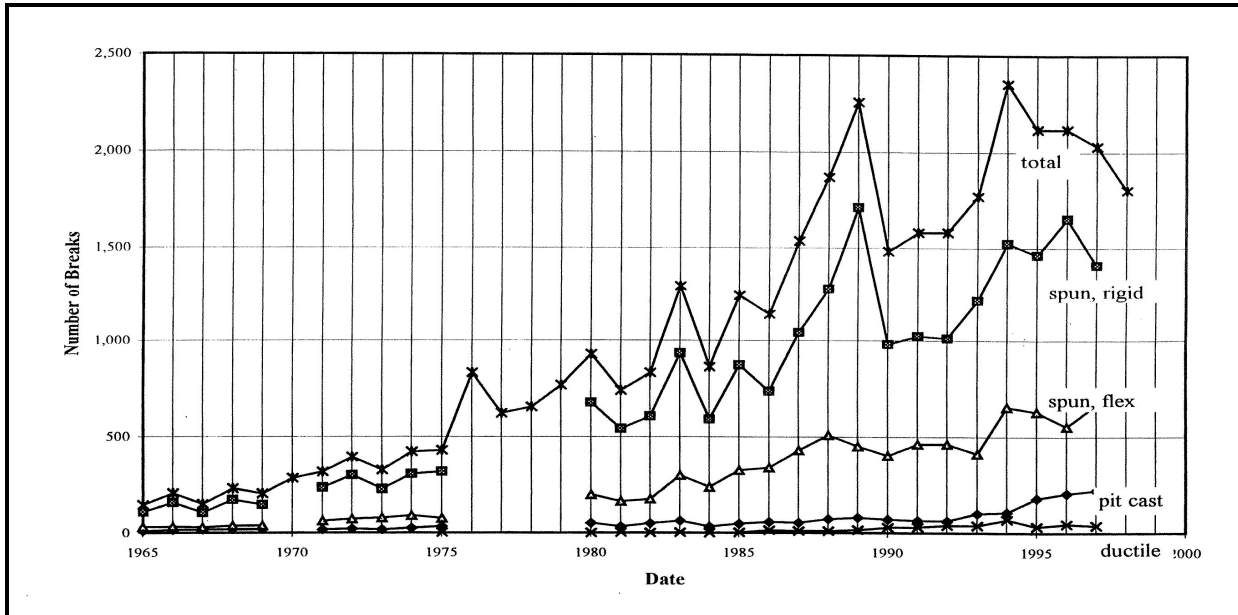
Exhibit No. 4
Main Breaks Since 1965

One of the key components of infrastructure assessment is the estimate of the useful life of the asset. When is it time to replace the pipe? The following case history illustrates this challenge in more detail. A large mid-western water utility has done considerable work in their efforts to manage main breaks over the last few years. The system serves over 300,000 customers with a distribution system of over 4,000 miles of mains. They currently experience about 2,000 breaks per year. This equates to about 5½ breaks per day. In December 1999 during a particularly cold period, it experienced 1,000 main breaks. Exhibit No. 4 shows that main breaks in the system have been increasing over the years, especially the rigid joint, spun cast iron pipe. Using this data, an engineering economic analysis was performed by analyzing data from a computerized leak database containing over 30,000 records since 1983. The result was a main break forecasting model for individual mains in the system and an engineering economic model to estimate the total life cycle costs of each pipe with three or more breaks.

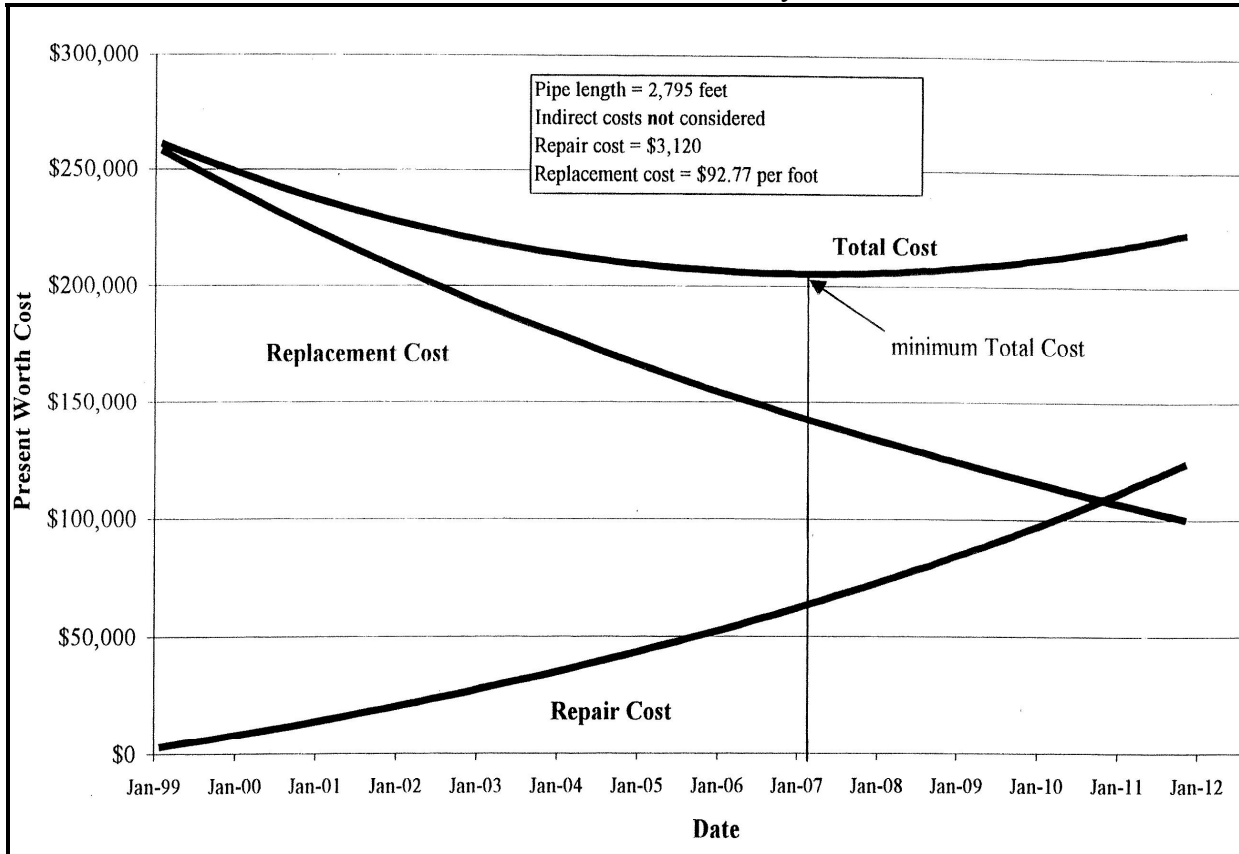
Exhibit No. 5
Economic Break Even Analysis

Exhibit No. 5 presents an example of a pipeline's total life cycle costs derived from the model. The line sloping downward indicates the present worth of the replacement cost. The line sloping upward indicates the cumulative costs to repair the pipe. The top line indicates the addition of the other two curves, which represents the total life cycle cost of the pipeline. In other words, it shows how much money must be set aside today to finance the continual repair and/or eventual replacement of this pipeline. From the graph, it can be concluded that the optimal time to replace the pipe is when the total life cycle cost reaches a minimum.

By applying this approach the utility could support that 146 miles of pipe should be replaced today, and furthermore, could identify the individual pipes that should be replaced. Although more analysis is required, the initiative is moving forward to phase in an accelerated main replacement program.

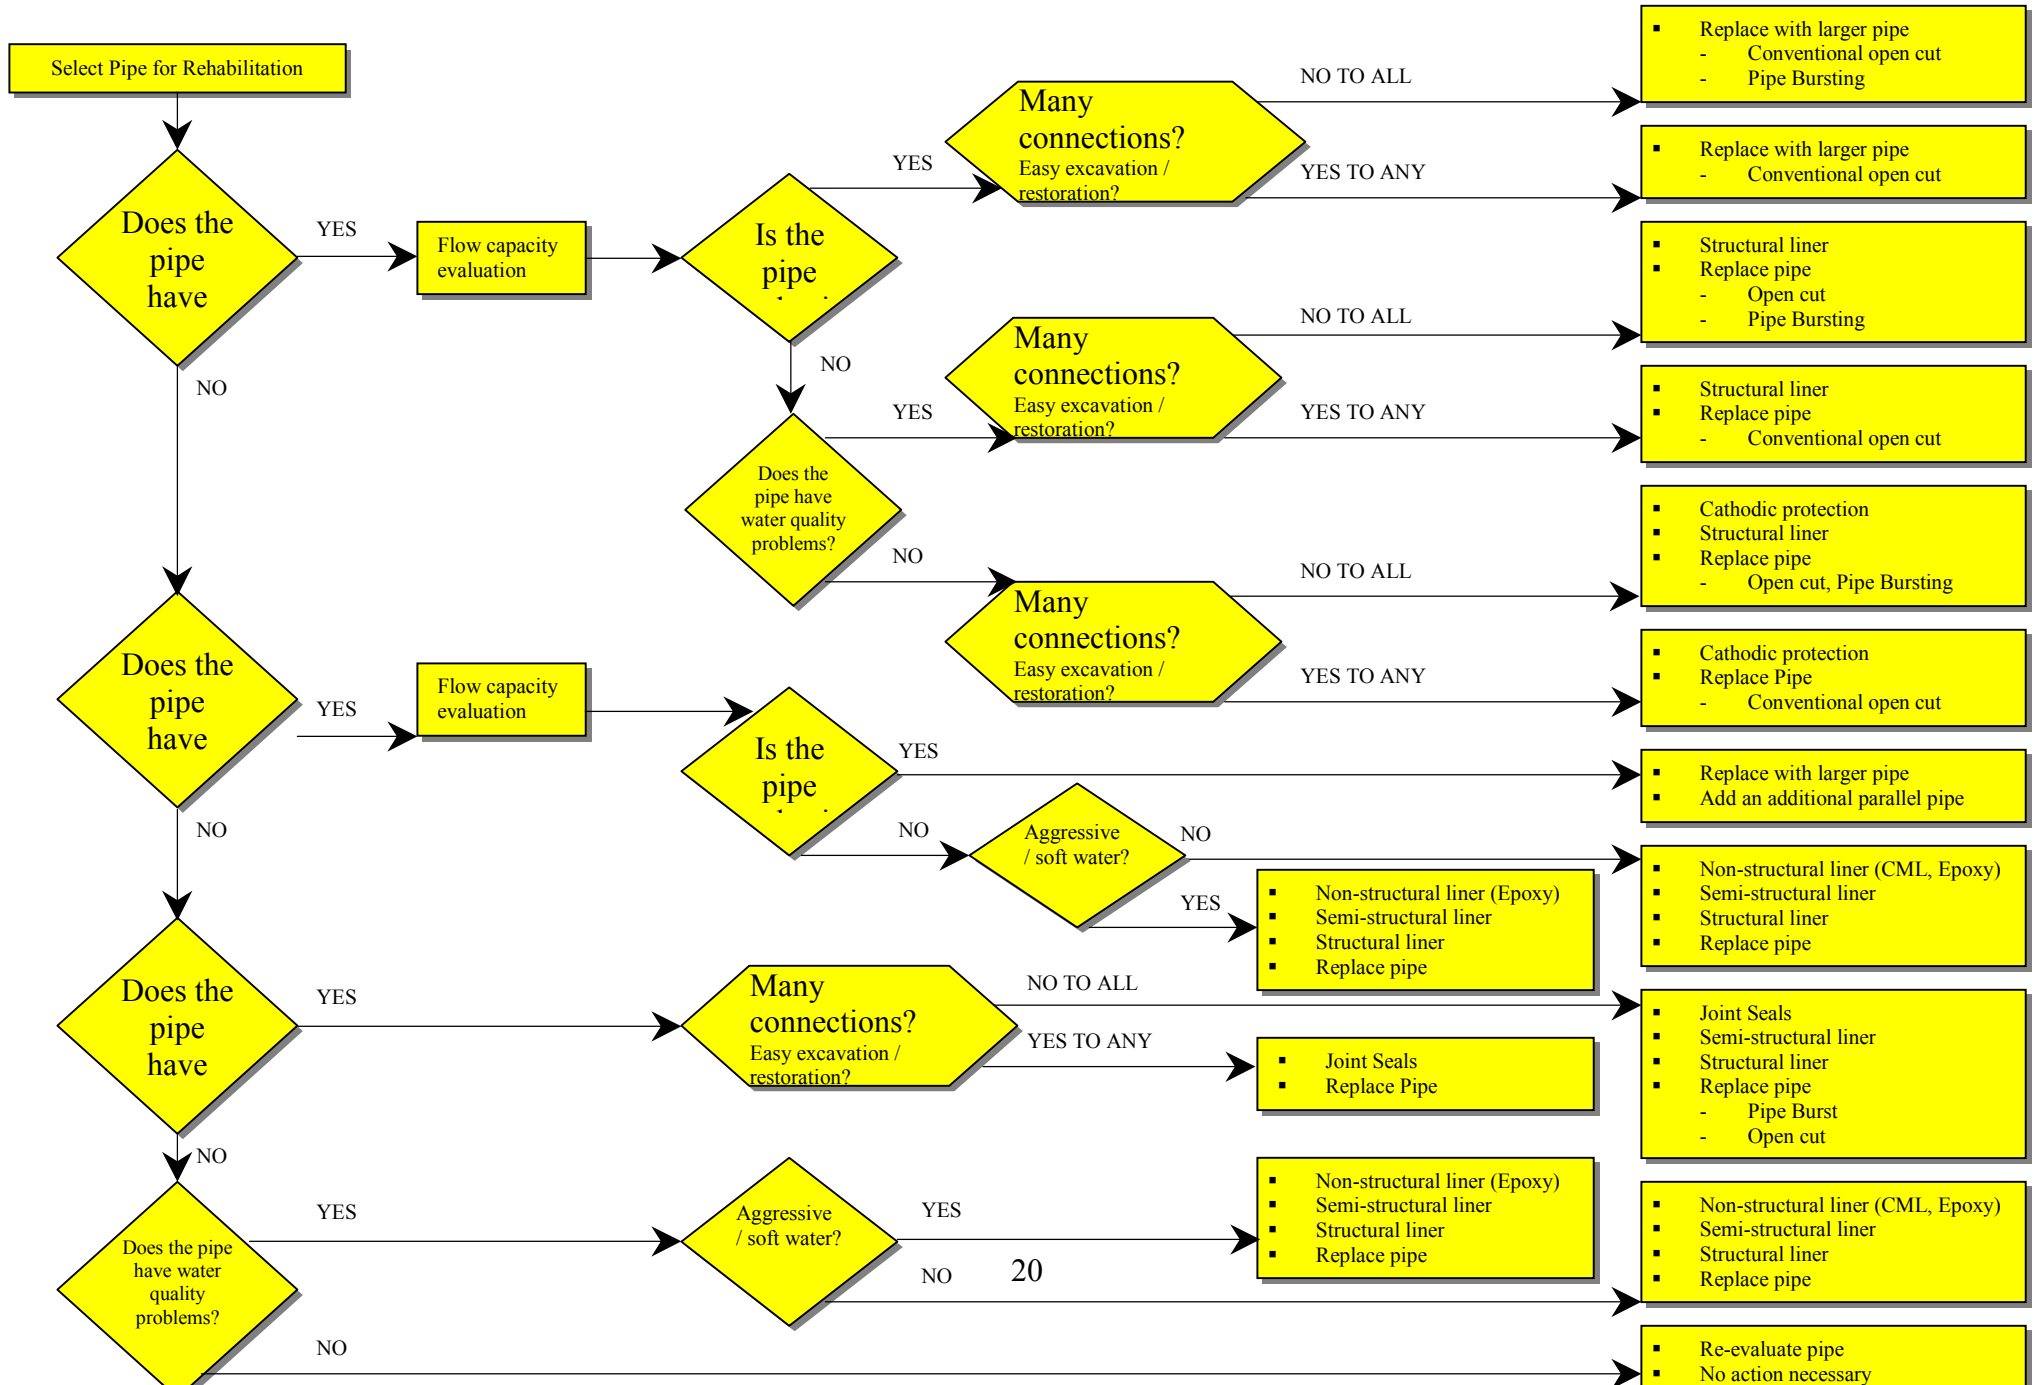
Exhibit No. 8 Rehabilitation Decision Tree

The selection of renewal technologies depends on pipe characteristics and site characteristics as well as the techniques themselves. The aim of the selection process is to consider all these factors to arrive at the most cost-effective, technically viable solution. Ideally, the cost estimate should include not only direct contracting and related costs, but also indirect costs associated with public disruption and longer-term maintenance. The most cost effective technology can then be selected using present worth (PW) analysis or equivalent uniform annual cost (EUAC) analysis. One approach to rehabilitation/replacement technique selection is summarized in Exhibit No. 8. This chart provides a framework for selecting or rejecting groups of techniques, depending on the nature of the performance problems, hydraulic requirements, and some site-specific factors.

Generally four types of problems (structural, hydraulic, joint leaks, and water quality) need to be evaluated in determining the options available for the pipe. This evaluation is performed in a hierarchical order, with the most critical pipe problems being addressed first and any remaining problems associated with the pipe being addressed by default. The following pipe problems should be evaluated when selecting renewal technologies:

- a. If the problem is structural (loss of strength), the options are replacing the pipe (same size or larger) or installing a structural liner. Using these options will also address hydraulic, joint leak, and water quality problems.

- b. If the problem is hydraulic (lack of adequate flow capacity) the options are replacing the pipe (same size or larger) or installing a structural, semi-structural, or non-structural liner provided the existing pipe diameter is adequate. Using these options will also address joint leak and water quality problems.

- c. If the problem is joint leaks, the options are replacing the pipe (same size or larger), and installing a structural or semi-structural liner. Using these options will also address water quality problems.

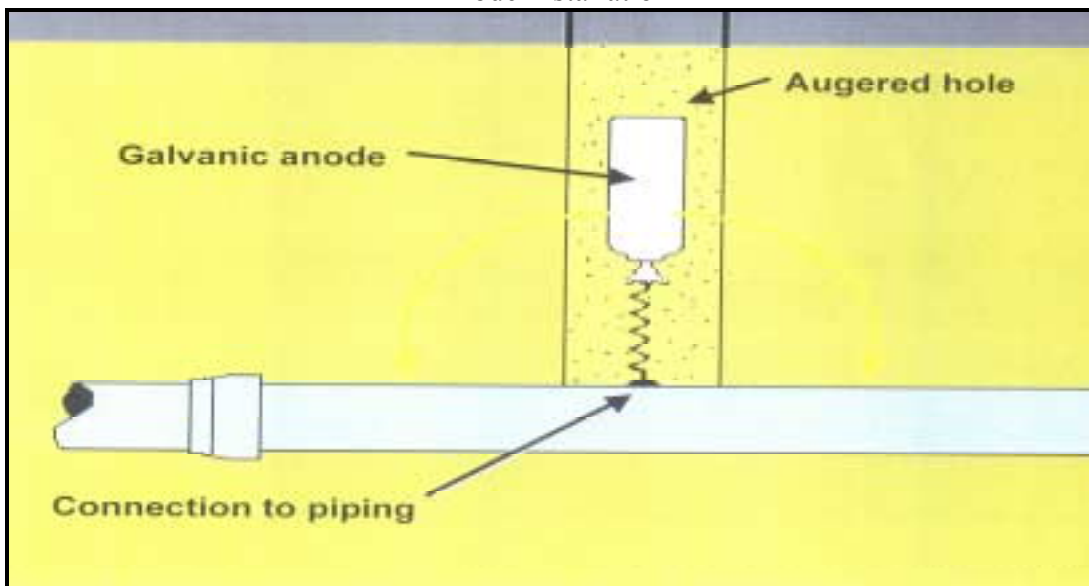
Exhibit No. 10
Anode Installation

Cathodic Protection is a technology for reducing corrosion of a metal water main by turning the entire main into the cathode of a galvanic or electrolytic corrosion cell. Normally, sacrificial anodes are used as the galvanic cell to minimize the effects of external corrosion on existing metal water mains, thus reducing water main breaks and extending the useful life of the mains. A sacrificial anode system does not stop the process of corrosion but rather redirects the corrosion from the water main to the anode. Exhibit No. 10 shows a typical installation of a galvanic anode. Sacrificial anode protection may be used in selective “hot spot” (highly corrosive soils) areas that have been located by soil-survey procedures. In corrosive soils, sacrificial anodes should be installed during the repair of water mains. Typically this would only increase the total cost of the repair by approximately \$200 - \$300 per break.

As a preventative maintenance program, sacrificial anodes are typically installed at 40-foot spacing (at every other joint) to be cost effective. This requires that rubber-gasketed joints be electrically bonded along the protected water main. It is also recommended that test-monitoring stations be installed at selected intervals along the water main to verify that the
